BELLA COOLA AIRPORT PAVEMENT CONDITION REPORT

Pavement Condition Assessment 2016 Bella Coola Airport

PRESENTED TO THE
Central Coast Regional District

OCTOBER 13, 2016
ISSUED FOR REVIEW
FILE: 704-TRN.AIRP03084-01

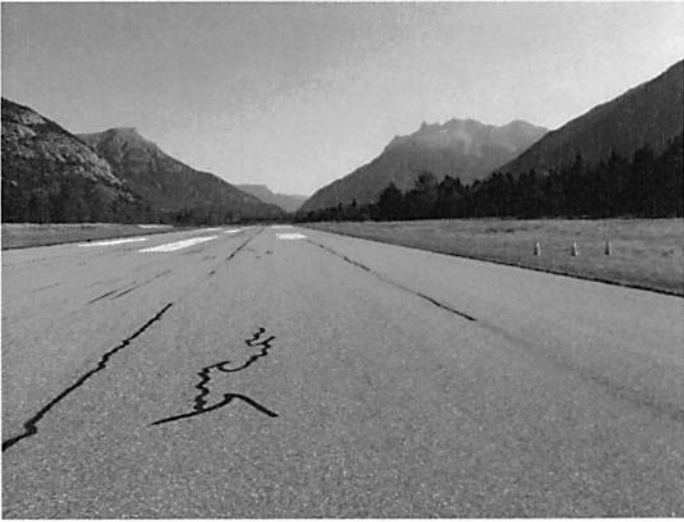
Photo 1: Low Severity Longitudinal Cracking near the Threshold or Rwy 05

To maintain a *GOOD* condition rating it is important that the cracks are filled and sealed on an annual basis. This will reduce the rate of degeneration of the asphalt surface.

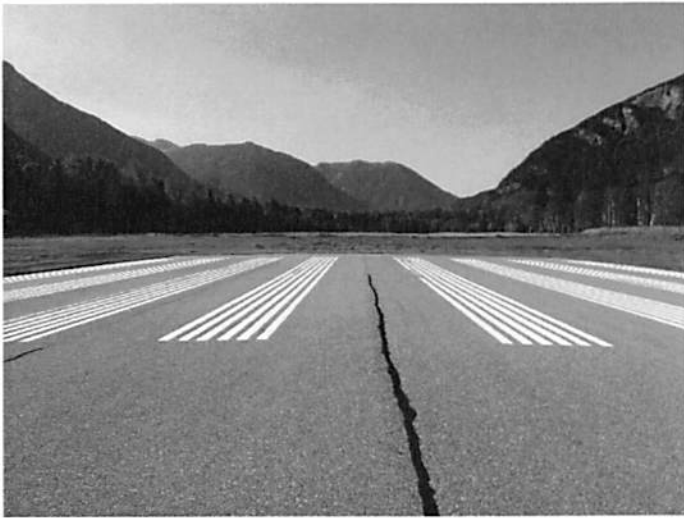
Photo 2: Low Severity Longitudinal Cracking near the Threshold or Rwy 05

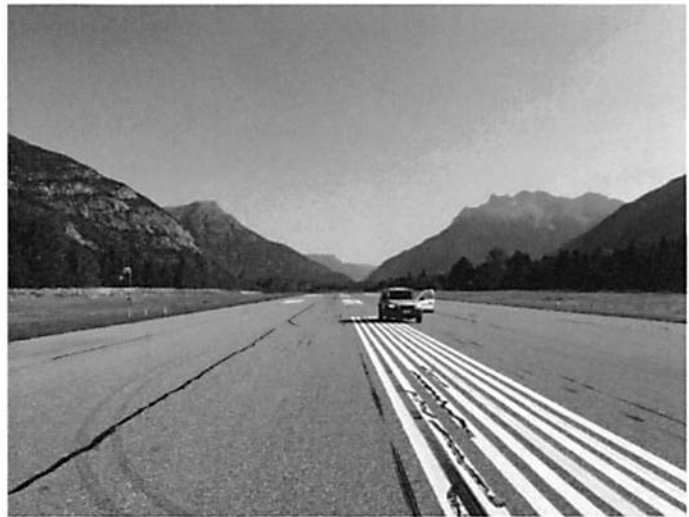
Photo 5: Low Severity
Longitudinal Cracking

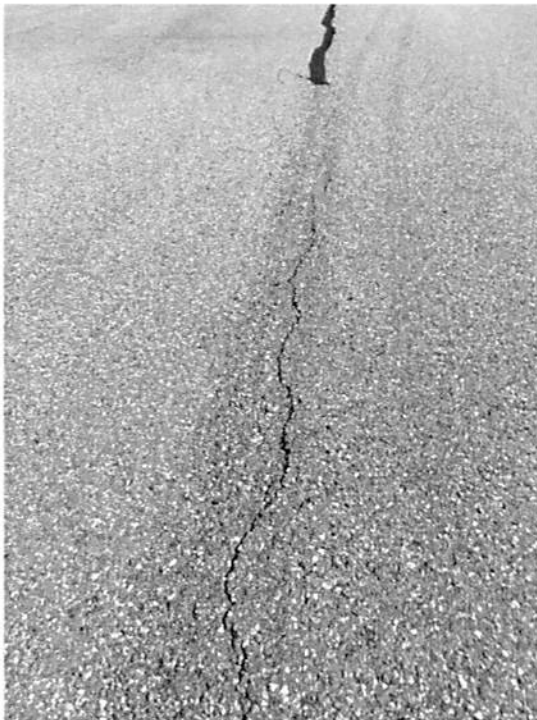
Photo 6: Low Severity
Longitudinal Cracking
Requiring Crack Sealant

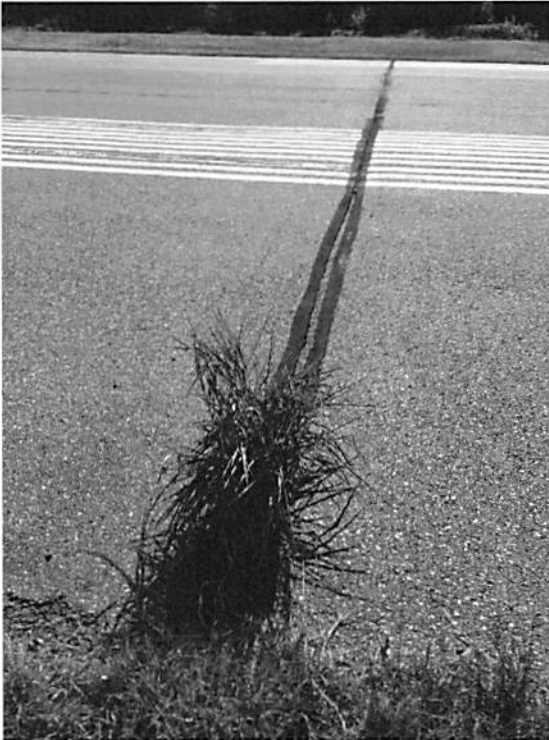
Photo 7: Vegetation Growth to be Removed

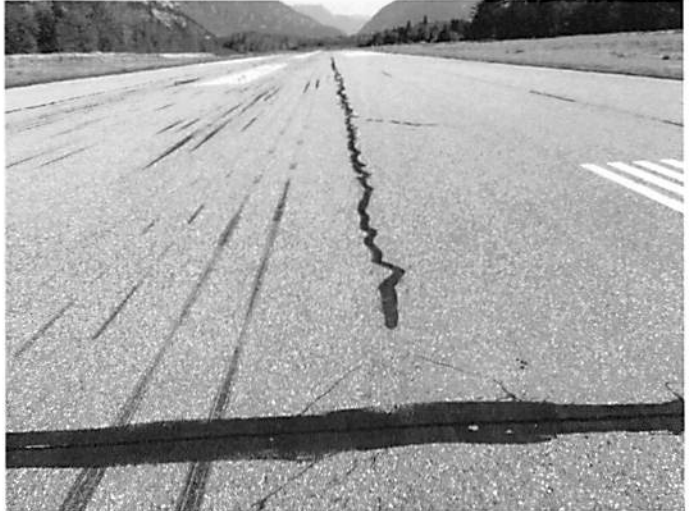
Photo 8: Transverse and Longitudinal Cracking (Sealed)

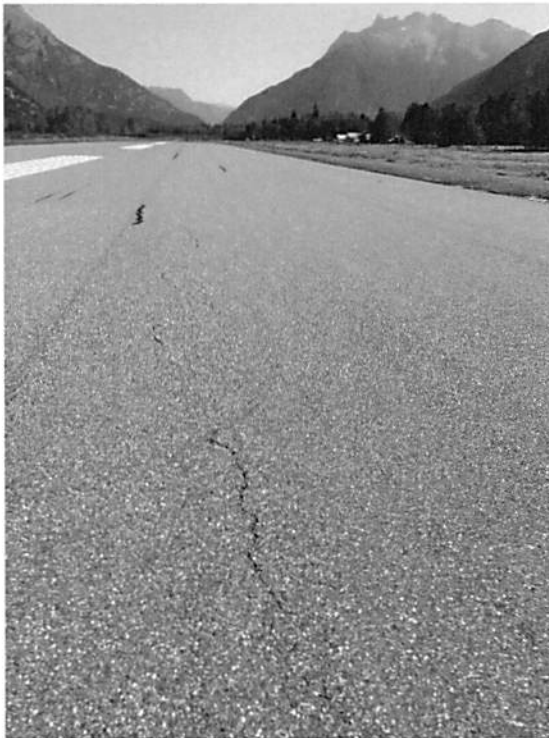
Photo 9: Low Severity un-sealed Longitudinal Cracking

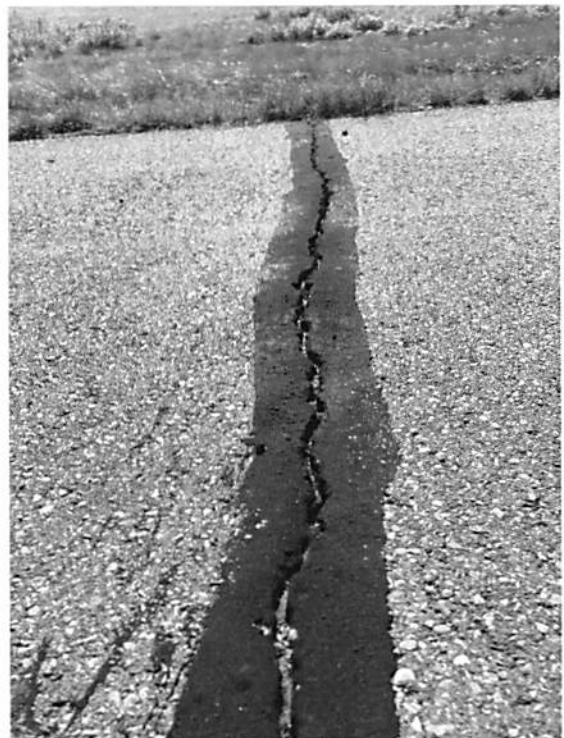
Photo 10: Transverse Crack Requiring Re-Sealing

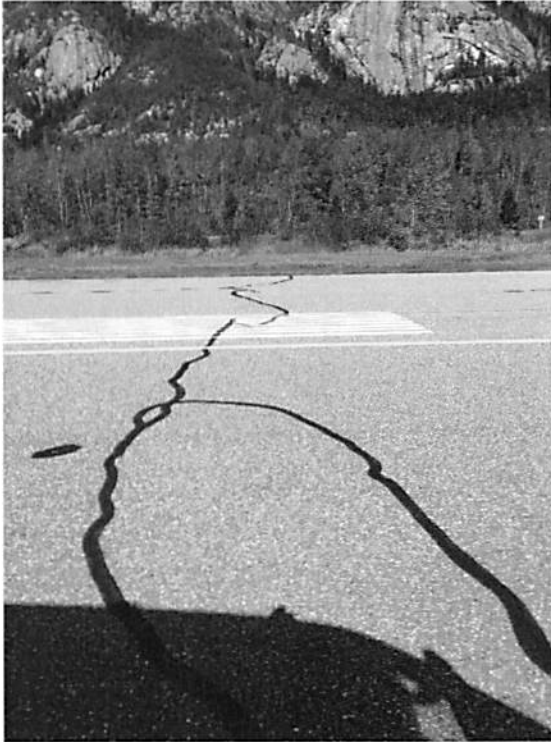
Photo 11: Sealed Transverse Crack

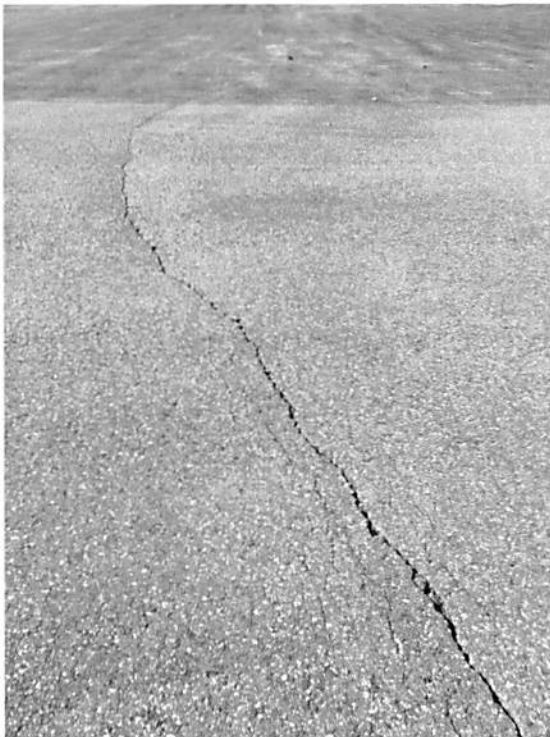
Longitudinal cracking is Moderate in extent and Medium in severity.

Photo 16: Low Severity Crack Apron I

To maintain a *GOOD/FAIR* condition rating it is important that all of the vegetation is removed and the cracks are filled and sealed on an annual basis. This will reduce the rate of degeneration of the asphalt surface.

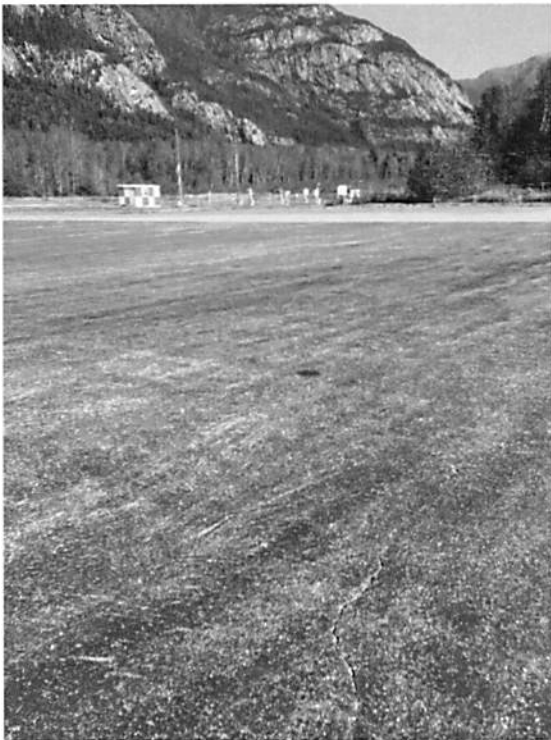
Photo 18: Low Severity Cracking on Apron I

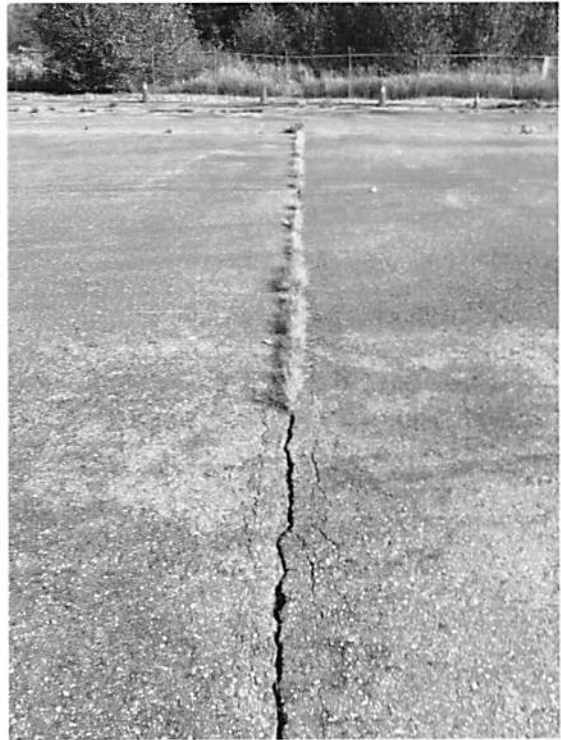
Similarly to Taxiway B, Apron I has more unfilled cracks that also include vegetation growth.

Photo 19: Vegetation Removal and Crack Seal
Required on Apron I

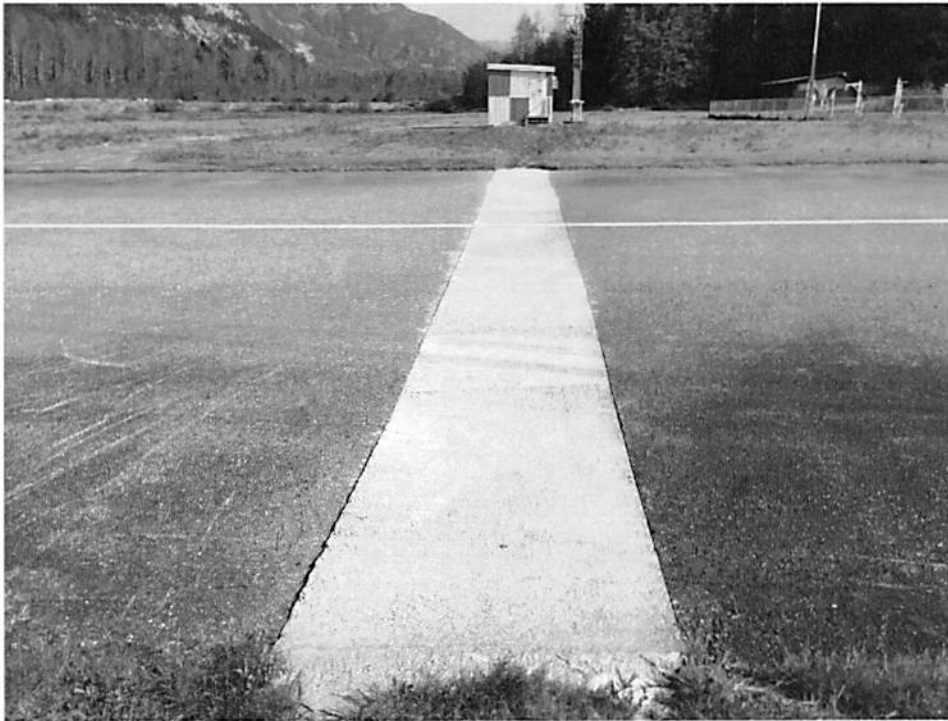
Photo 20: Trench Patching Across Taxiway A

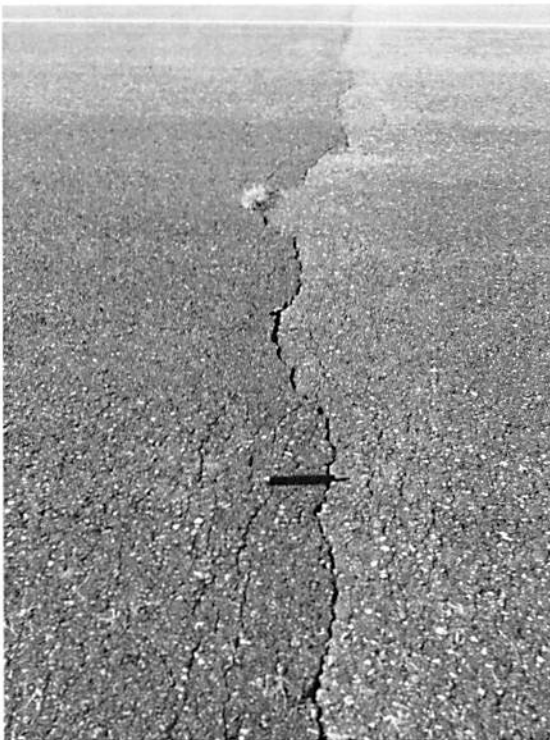
Transverse cracking is Minor in extent and Moderate in severity.

Photo 21: Transverse Crack on Taxiway A

As with the runway, to maintain a *GOOD/FAIR* condition rating it is important that the cracks are filled and sealed on an annual basis. This will reduce the rate of degeneration of the asphalt surface.

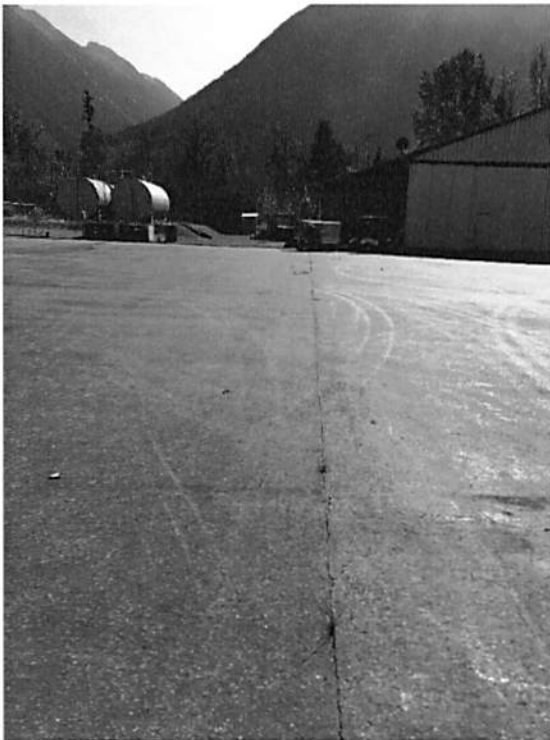
Photo 24: Crack Between Apron I
and the Itinerant Apron

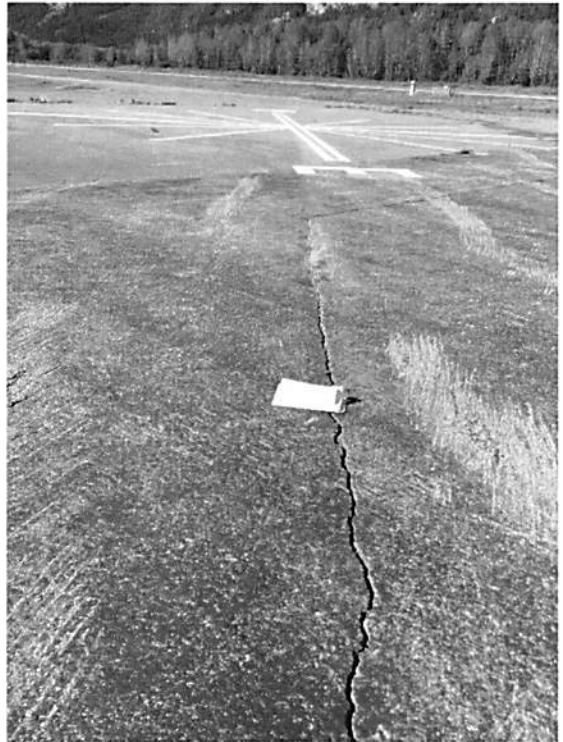
Photo 27: Moderate Crack on Apron I. Requires Sealant

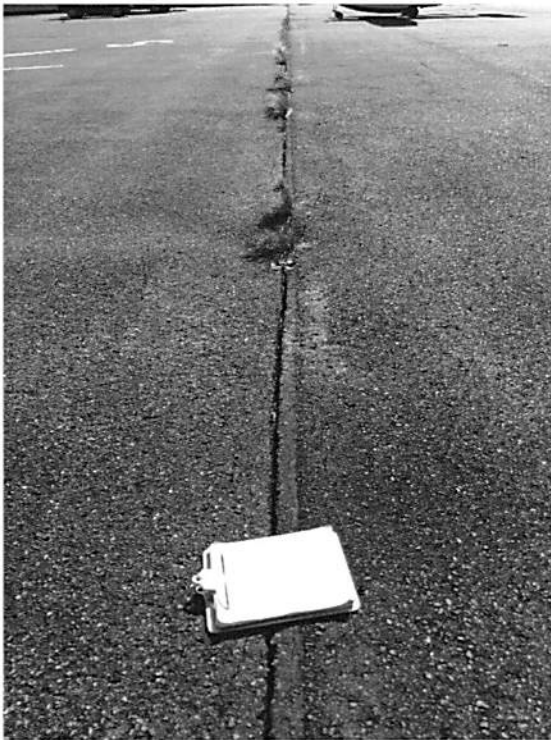
Similarly to Taxiway B and Apron I, the itinerant Apron has unfilled cracks that also include vegetation growth.

Photo 28: Sealant and Vegetation Removal Required on Itinerant Apron

To maintain a *FAIR* condition rating it is important that all of the vegetation is removed and the cracks are filled and sealed on an annual basis.

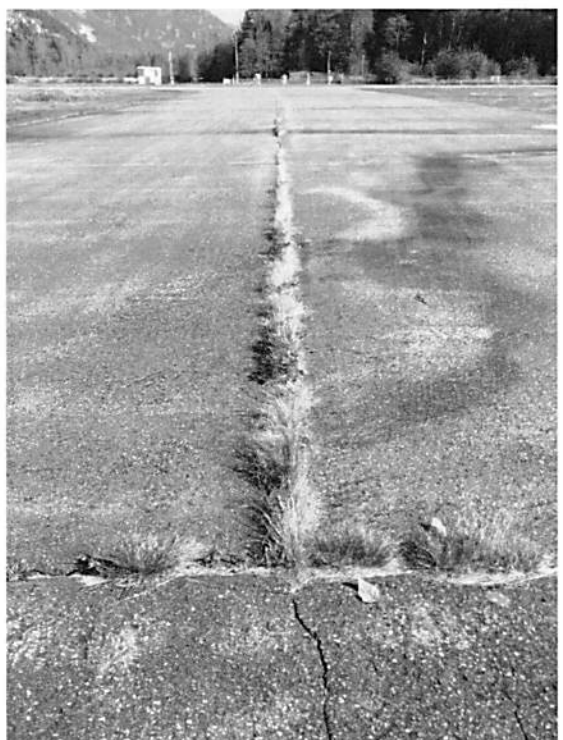
Photo 29: Sealant and Vegetation Removal Required on Itinerant Apron

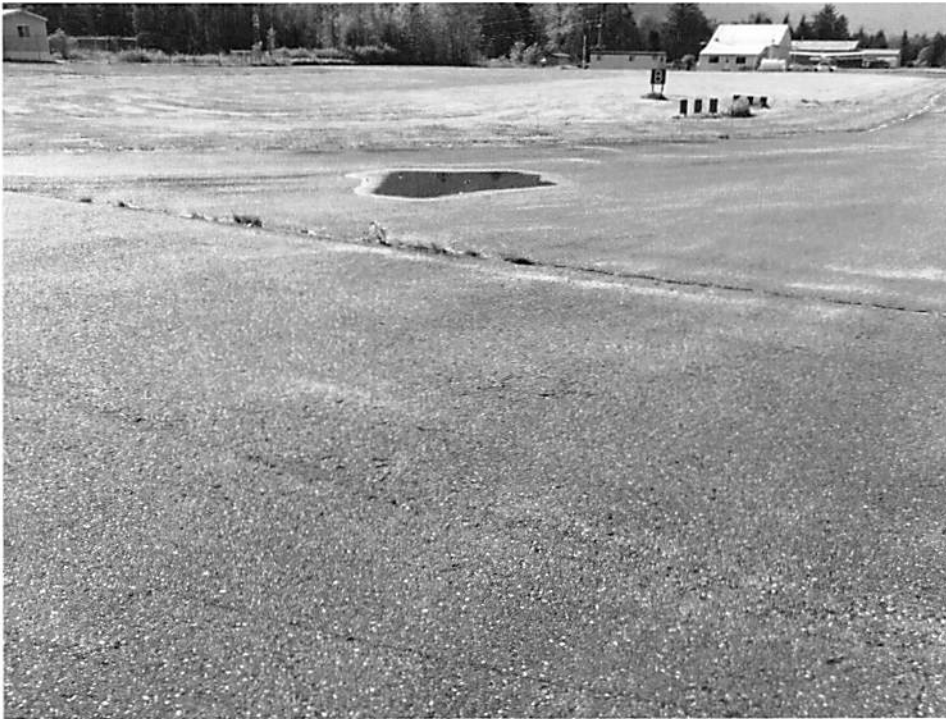
Photo 30: Ponding and Settlement on Taxiway B

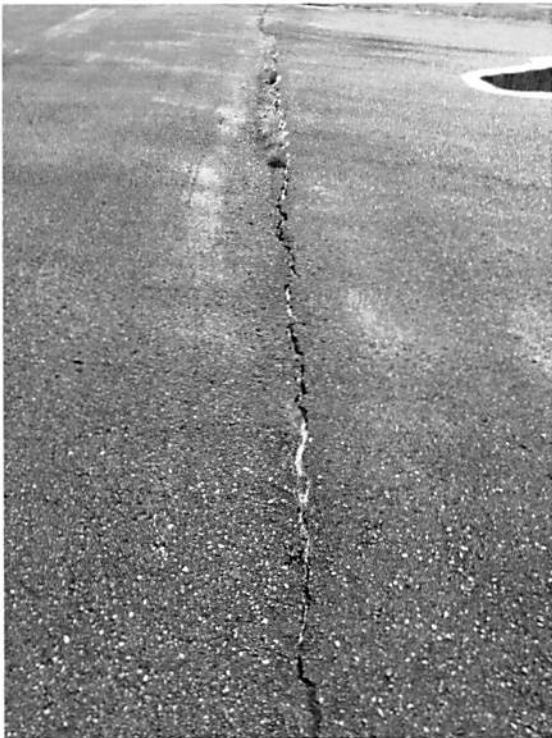
The surface has not been rehabilitated since 1996. Taxiway B contains more unfilled cracks when compared with the Runway and Taxiway A.

Photo 31: Unfilled Crack on Taxiway B

To maintain a *FAIR* condition rating it is important that all of the cracks are filled and sealed on an annual basis. This will reduce the rate of degeneration of the asphalt surface.

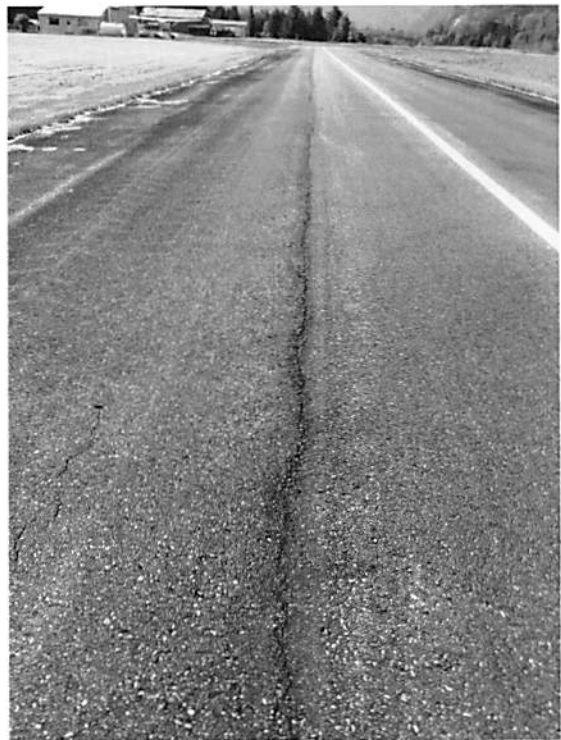
Photo 32: Unsealed Crack on Taxiway B

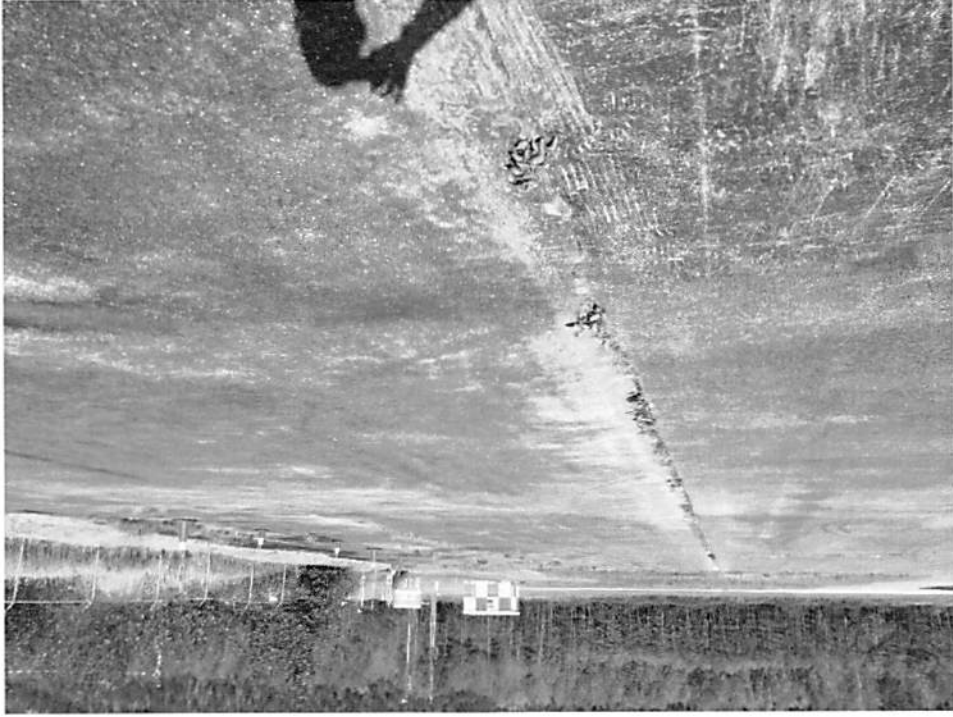
Transverse cracking is Minor in extent and Moderate in severity.

Photo 33: Transverse Crack on Taxiway B

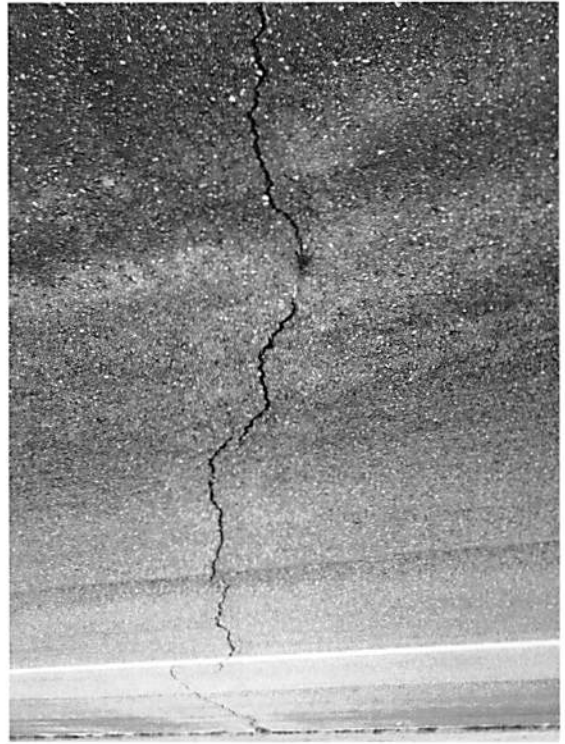
Photo 34: Crack Requiring Vegetation Removal and Sealant on Taxiway B

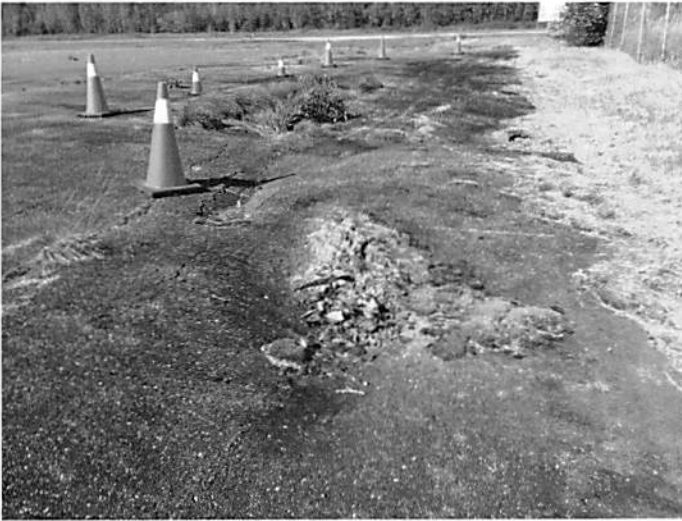
The Apron Tie-Down area east of Apron I was overlayed with asphalt in 1996. The overlay was completed without reconstructing the underlying areas and has now failed due to settlement of the subgrade. It appears the subgrade included organics and wooden stumps which have since rotted. The area is closed to aircraft traffic and marked as a hazard with plastic cones. The area is rated as *VERY POOR*.

Photo 36: Major Settlement at Apron Tie-Down Area

There are no immediate recommendations for the Tie-Down Area than it will require reconstruction to be made useable again.

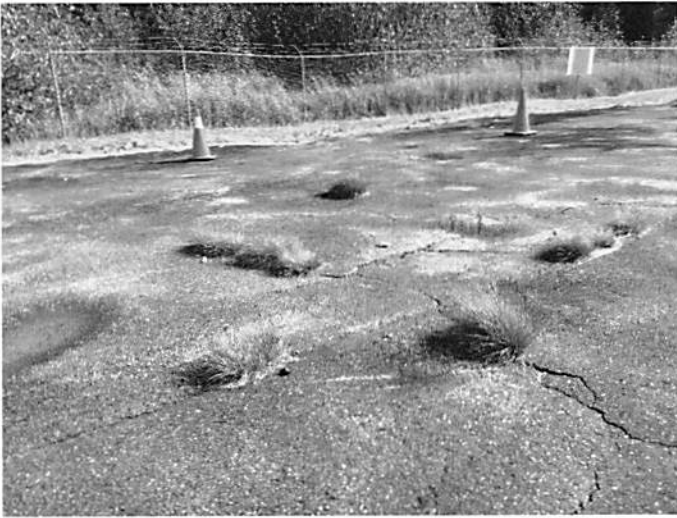
Photo 37: Major Settlement at Apron Tie-Down Area

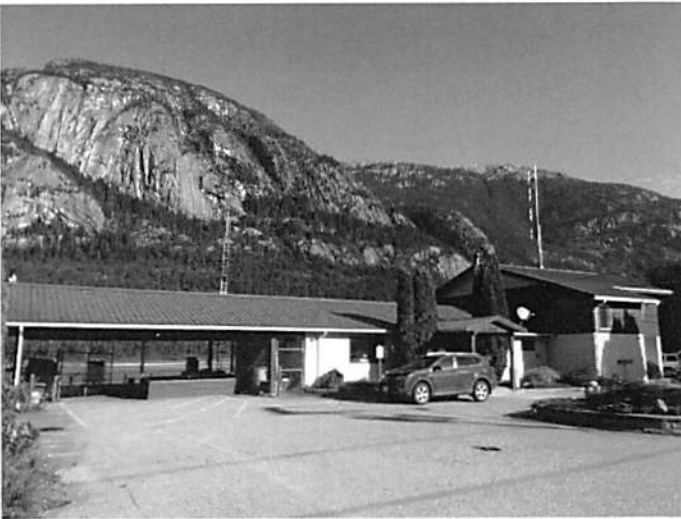
The Terminal Approach Road/Frontage Road/Exit Road are all in *POOR* condition due to age, ravelling, cracking and pot holes.

Photo 38: Terminal Frontage Road

The Ground side Roads and Paved Parking Lot should be overlaid with a new asphalt surface as soon as possible. If overlay is not feasible at this time, pot holes should be patched with asphalt until such time that the areas can be paved.

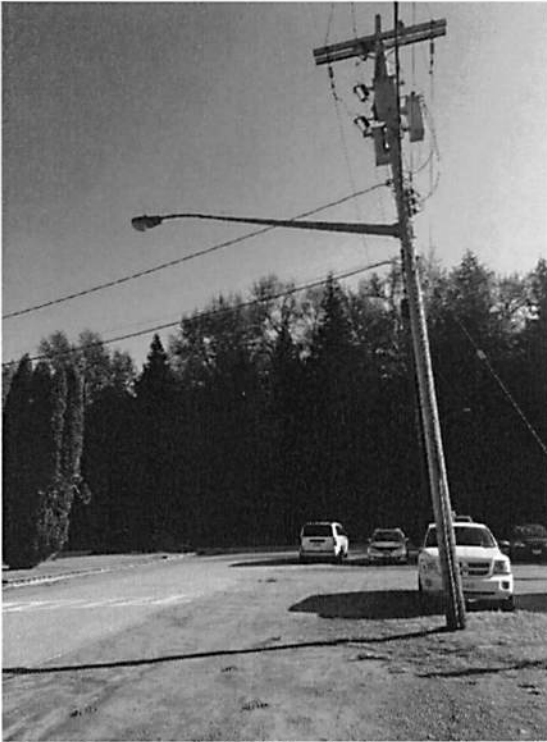
Photo 39: Terminal Exit Road and Parking

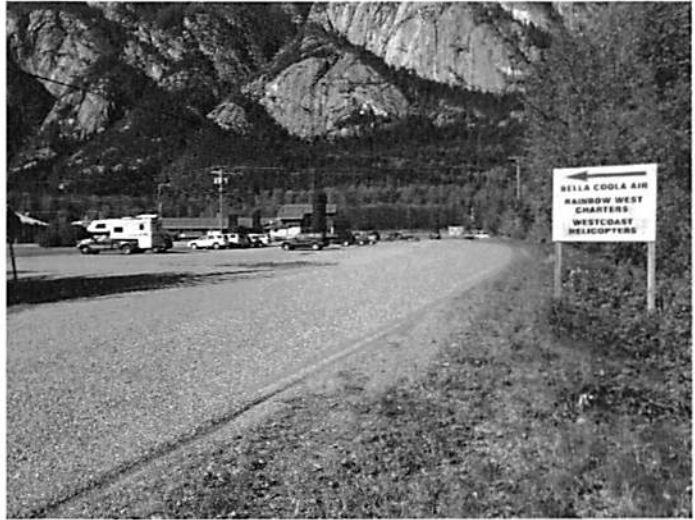
Photo 40: Travelling along the Terminal Approach Road

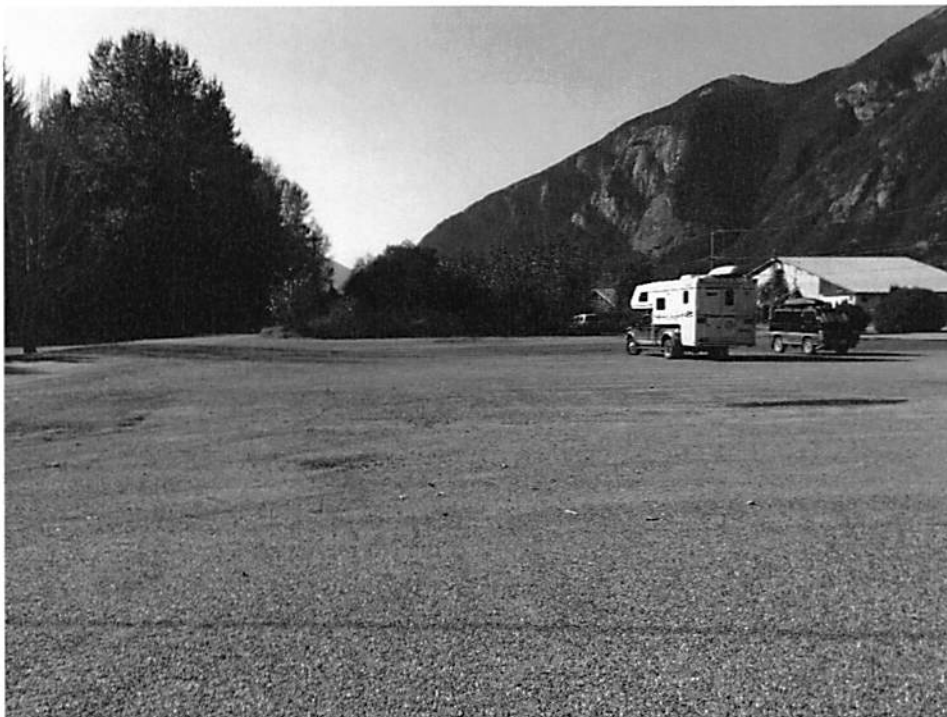
The paved Parking Lot adjacent the Terminal Approach Road appears to be in the same condition as the roads and is rated as *POOR*.

Photo 41: Paved Parking Area

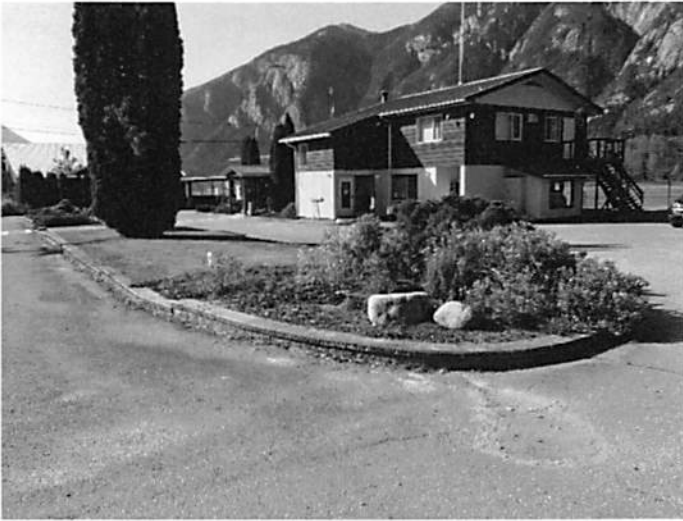
Photo 42: Ponding and Settlement Along Terminal Approach Road

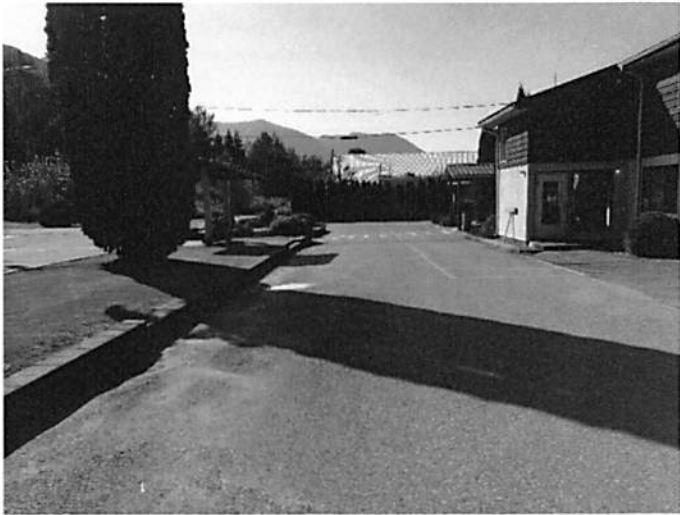
Photo 43: Settlement and Ponding along Terminal Frontage Road

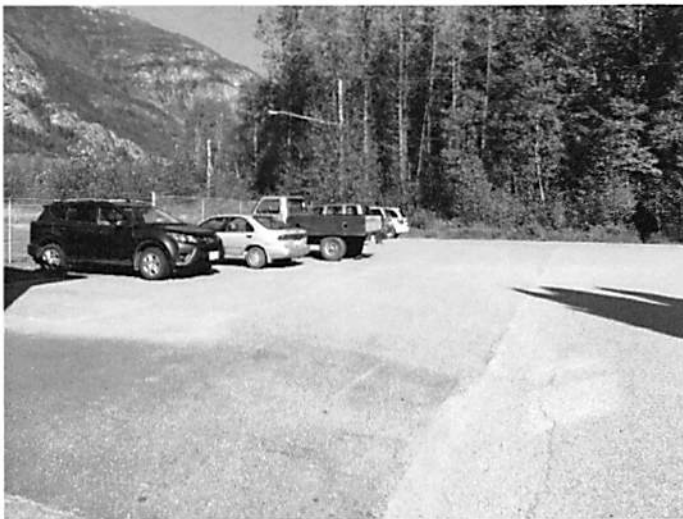
Photo 44: Cracking and rough Surface in Terminal Parking Area

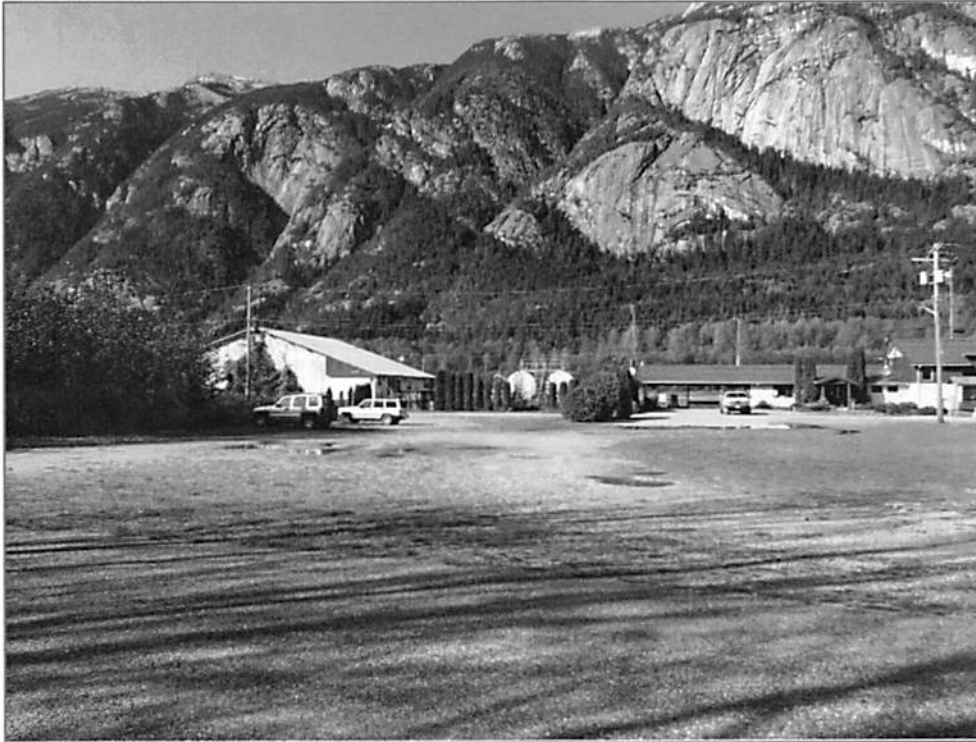
The gravel Parking Lot west of the paved lot is rated *POOR* due to pot holes and lack of drainage.

Photo 45: Settlement and Ponding in Gravel Parking Area

The Gravel Parking area should have enough new gravel added to allow drainage to be effective.

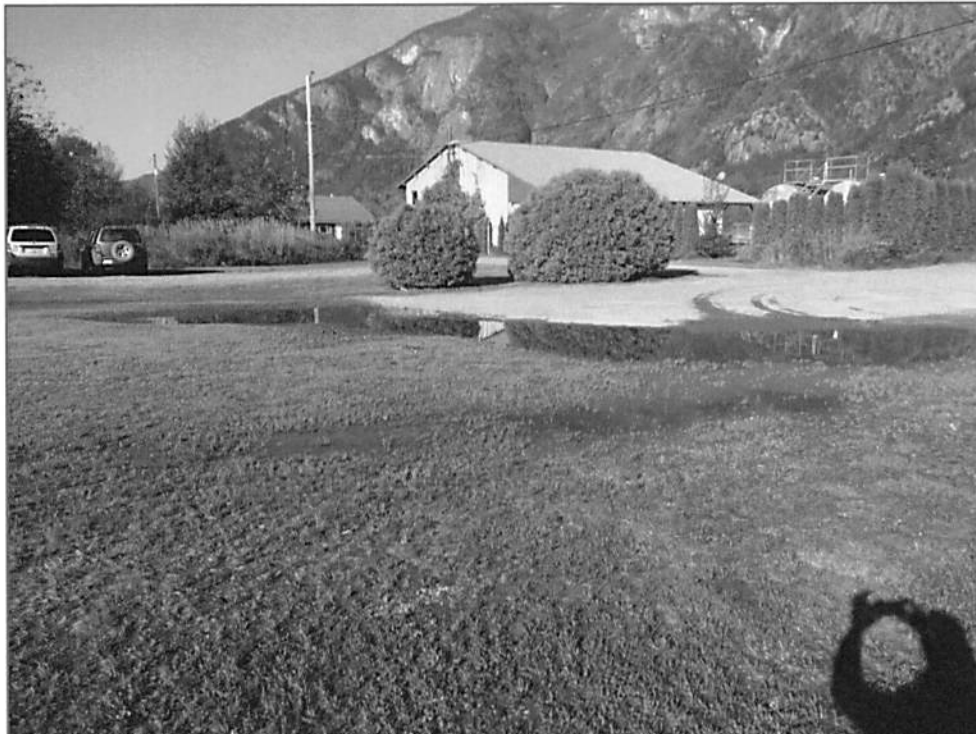
Photo 46: Settlement and Ponding in Gravel Parking Area
