Re: Centennial Pool Upgrade Project 2019
Bella Coola, BC

Fraser Valley Engineering Ltd. (FVEL) was retained by the client to conduct a geotechnical assessment for the proposed pool upgrade located at above mentioned address.

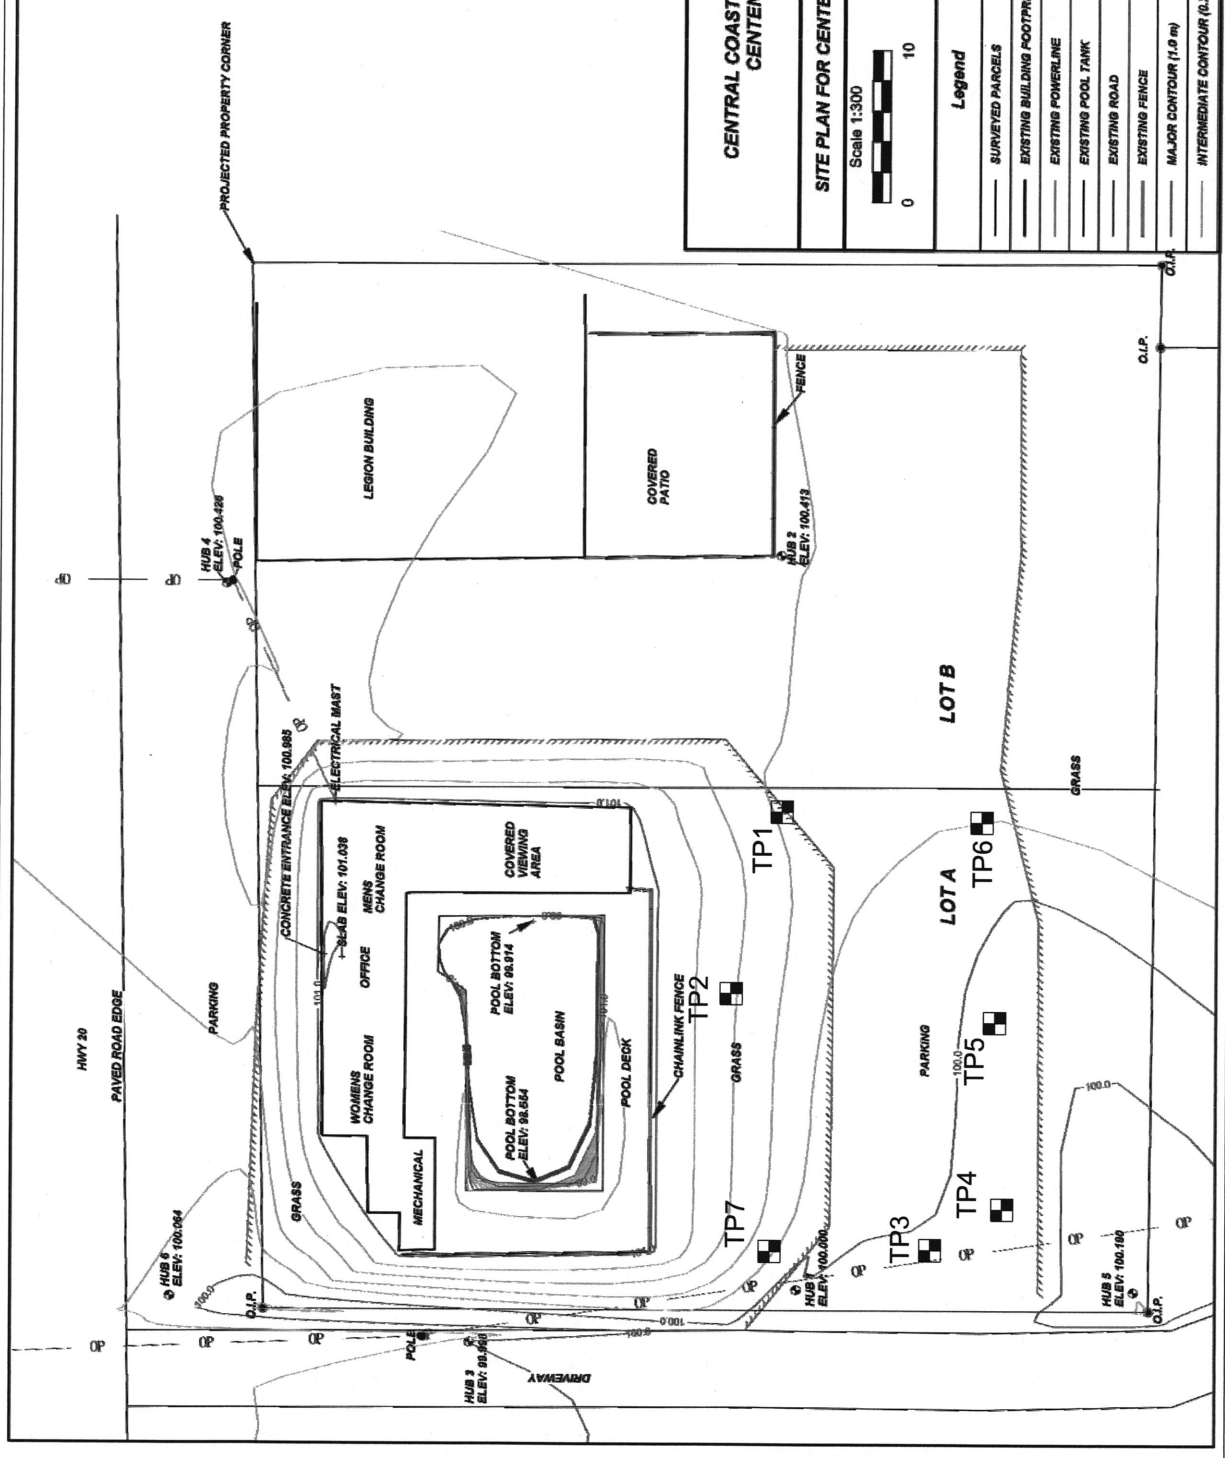
SITE PLAN FOR CENTENNIAL POOL RENEWAL PROJECT 2019 - 2021

Scale 1:300	CCRD OPERATIONS DEPT. RECREATION INFRASTRUCTURE
	DATE OF SURVEY: OCTOBER 28, 2019
Legend	FIELD CREW: KIM AE
— SURVEYED PARCELS	DATA ON RECORD: KEN MCILWAIN
— EXISTING BUILDING FOOTPRINT	CHECKED BY: KEN MCILWAIN
— EXISTING POWERLINE	DRAWING NO.: P2019-04
— EXISTING POOL TANK	DATE OF ISSUE: NOVEMBER 8, 2019
— EXISTING ROAD	REVISION NO.:
— EXISTING FENCE	PLAN SCALE: 1:500
— MAJOR CONTOUR (1.0 m)	SHEET: 1 OF 1
— INTERMEDIATE CONTOUR (0.3 m)

part trace of silt. Alluvium is loose, unconsolidated (not cemented together into a solid rock) soil or sediment that has been eroded, reshaped by water in some form, and re-deposited in a non-marine setting. Alluvium is typically made up of a variety of materials, including fine particles of silt and clay and larger particles of sand and gravel. However; no trace of clay was seen during our investigation and the silt amount in the test pits was minimal. Water table was found at approximately 1.2 m below the existing grade. Test pit logs and location plus percolation testing results are attached.

TP No.	Depth (ft)	Soil description
TP1	0.0-0.5	Grass and top soil
	0.5-6.0	Gravel and cobbles, sun round, looks like a trench backfilling, some sand, cave in from 1 ft to bottom of hole, gravel size decrease in size by increase in depth
		10 m from building corner
		Water table @ 4.5 ft from grade
TP2	0.0-0.5	Grass and top soil
	0.5-2.5	Silty sand, damp to moist, loose to compact, light brown
	2.5-6.0	Gravel and cobble with sand, grey, this material was typical of area as per hoe operator and Ken
		Water table @ 4.0 ft from grade
		18 m from SW of fence corner, 14 m from SE of fence corner
TP7	0.0-0.5	Grass and top soil
	0.5-1.5	Fine and with some silt, loose to compact
	1.5-7.0	Gravel and cobbles, some sand, fine to medium in size
		8.5 m from SW fence corner
		Water table @ 5.5 ft from grade
